S20 MULTIPLE-TONE GENERATOR II.

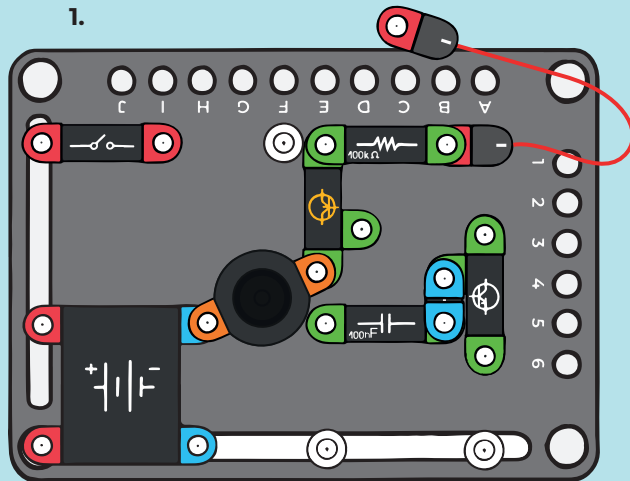
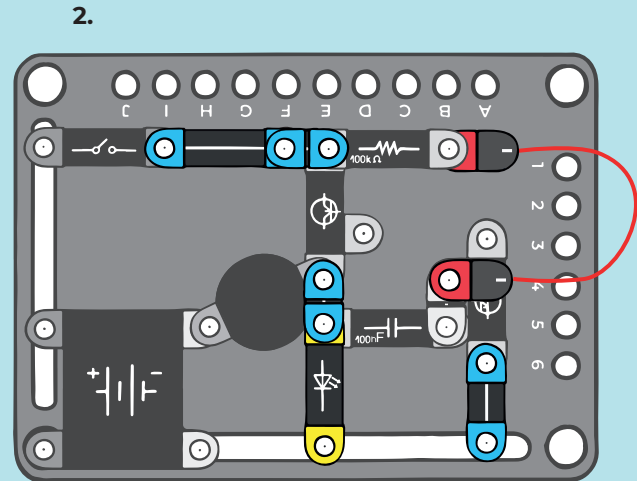
We replace the buzzer with a capacitor with a capacitance of 100 nF. The capacitance is higher, and the tone pitch decreases. Again, the LED only appears to be constantly lit, but the brightness has changed. A good eye can already notice a hint of flicker – like rapid fluctuations in brightness.
