### S30 MULTIPLE-TONE GENERATOR III.

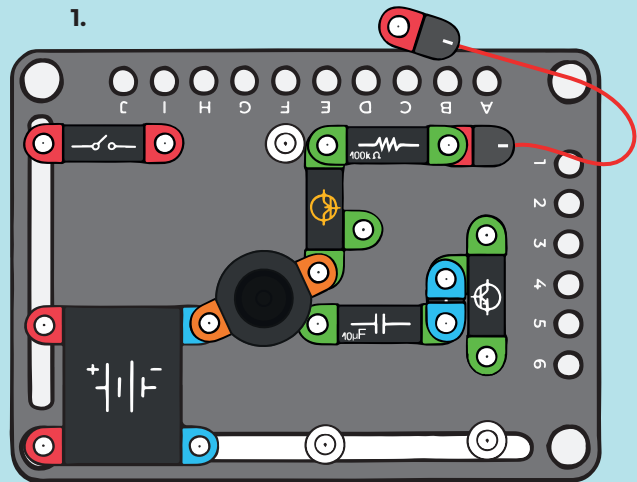
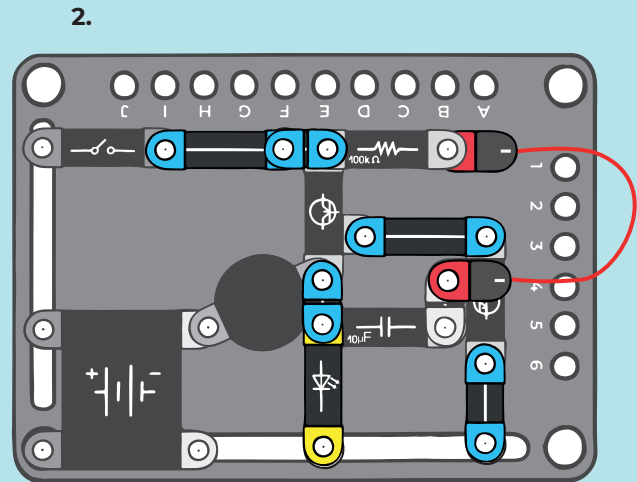
Replace the capacitor with a capacitance of 100 nF with a capacitor with a capacitance of 10 μF. This capacitance is many times higher, and the continuous tone falls apart into mere clicking. The LED flashes. The generator frequency has dropped below the limit that a person can audibly perceive as a continuous tone.
